Vine Brook and Willard's Brook Stream Shoreline Surveys

May 9, 2009
Lexington, Massachusetts

Conducted by the Watershed Stewardship Program,
a joint program of Lexington's Conservation Division,
Engineering Division, and citizen volunteers

Compiled by Emily Schadler and Tom Whelan
December 8, 2009

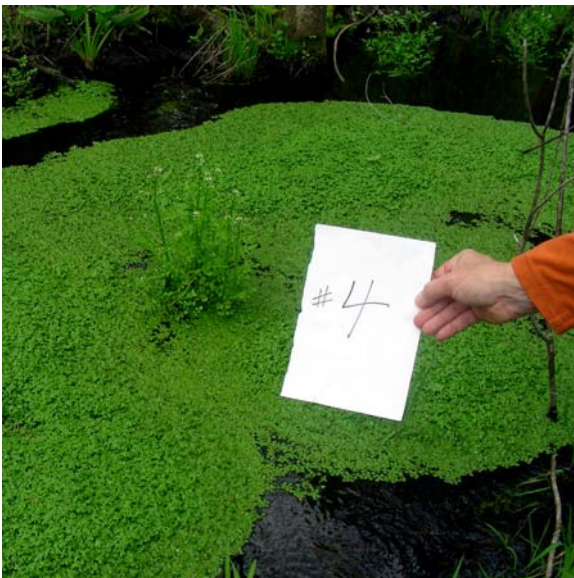
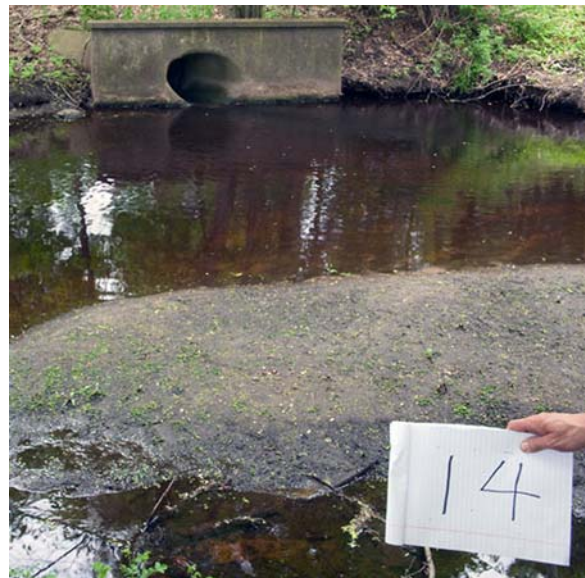
Volunteers documented certain features with photographs, such as the duckweed and sediment above.

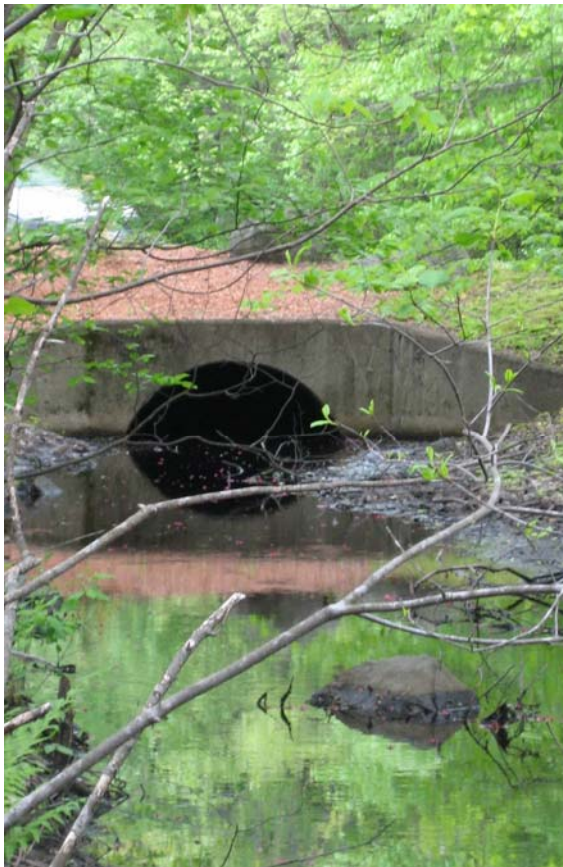
Outfall located on Vine Brook at Worthen Road.

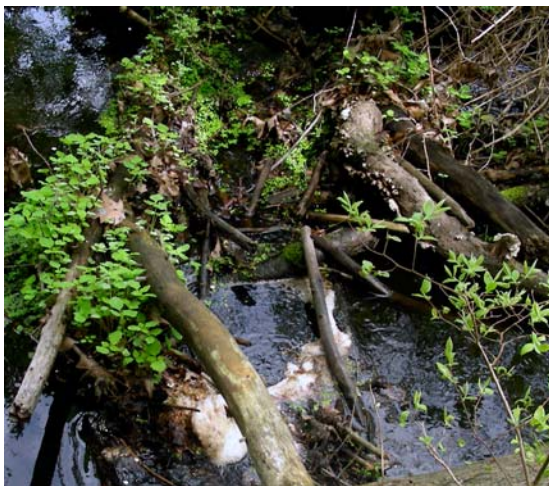
Woody debris and other organic matter spanning a stream bed.

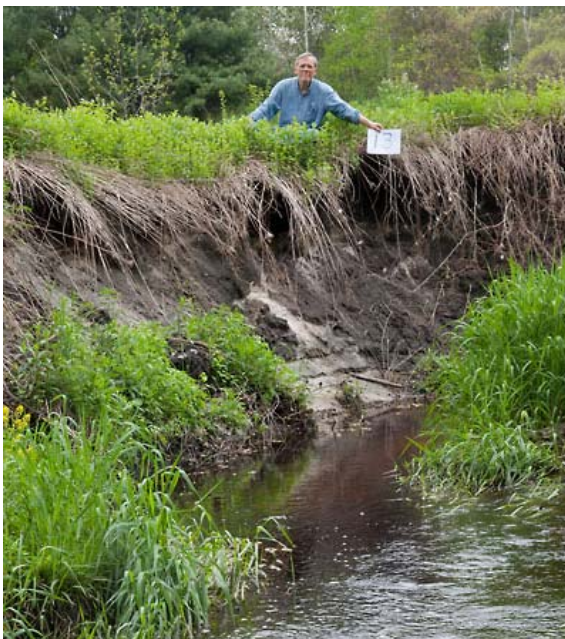
Bank erosion on a stretch of Vine Brook.

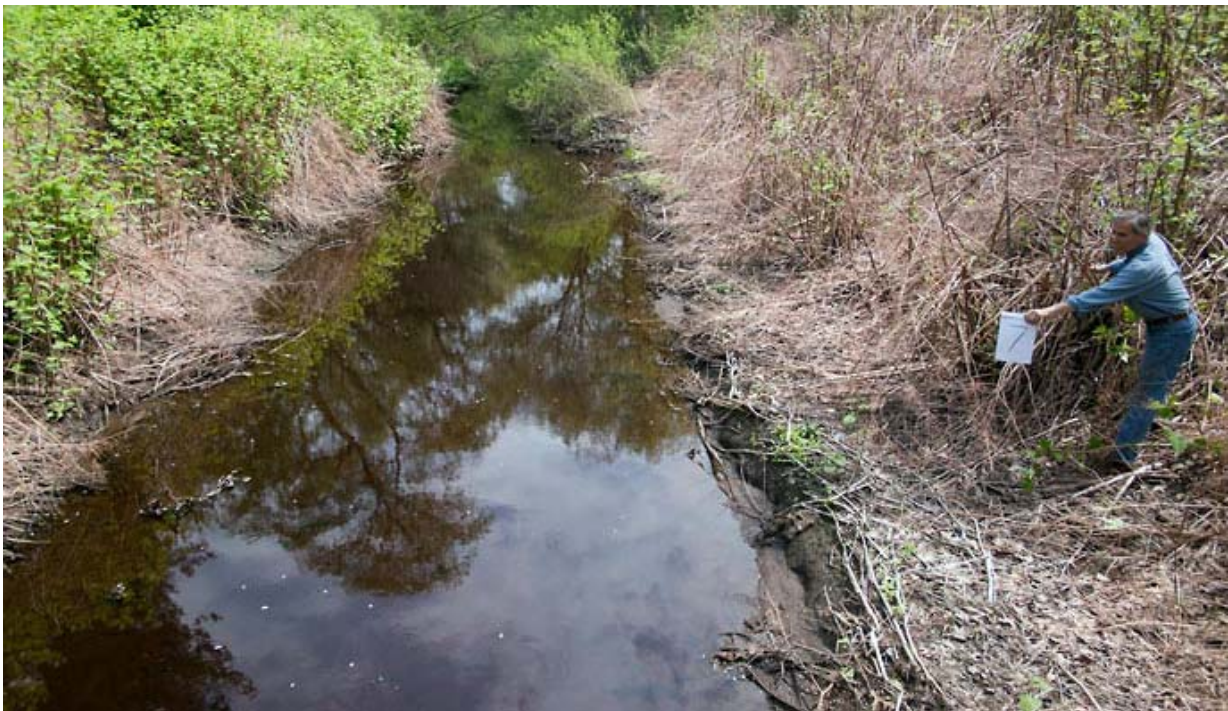
Japanese knotweed growing along the banks of Vine Brook.
