Address 7 Carville Avenue

Repair ~~Renewal~~ ~~New Service~~ W.O. #1622

TOWN OF LEXINGTON — BOARD OF PUBLIC WORKS
SEWER DIVISION

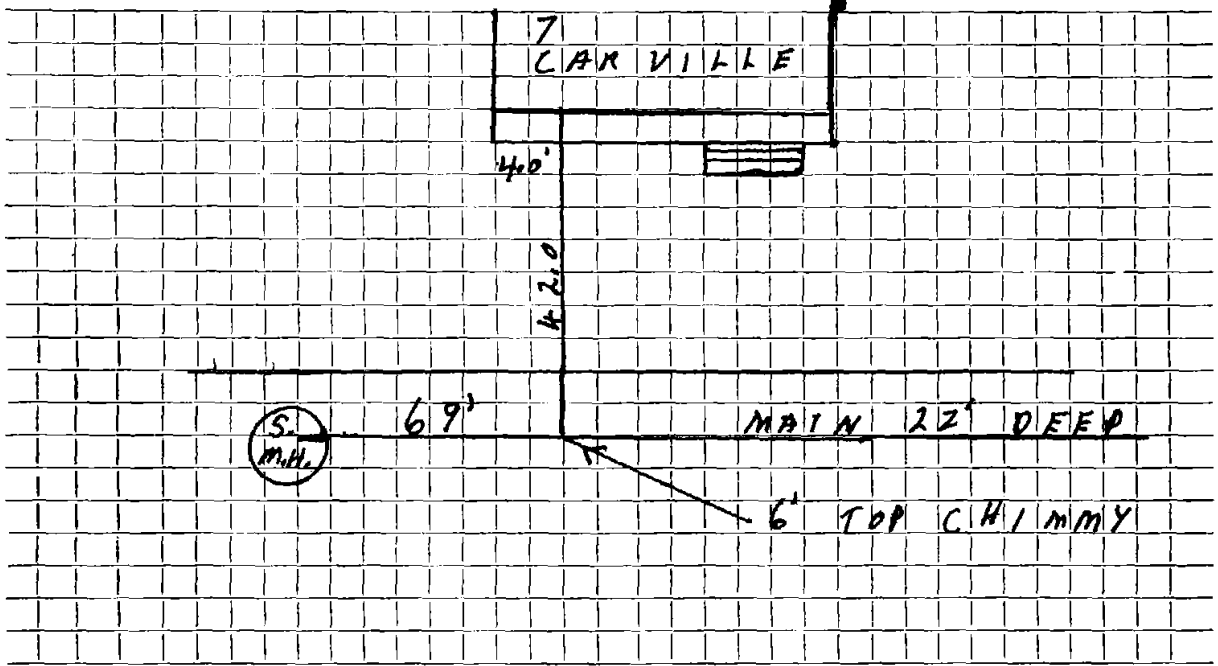
Sketch of Service Here

Date	Material	Amount	Total	Date	Amount
8-21-42	44' 6" Sewer Pipe				
	1 6" Elbow				
					Repair
				3/10/81	Labor
				5/6/81	"
				1	6" x 2' Transite Nipple
				1	6" x 3' Transite Nipple
				1	6" 90° Transite Elbow
				1	6" Fernco Adapter
				6	yds. Gravel
					Patch 10 x 8
				4	hrs. Trucking
				4	hrs. Town Shovel
				1-5-79	solids 32' out
				1-10-68	Pipe Repair
				1-9-68	BROKEN AT Elbow
				12-27-67	Pipe MUST be broken AT Elbow
				10-12-65	RAGS + DEBRIS

Remarks: Repaired at Elbow 42' out from house, 69' down from S.M.H. 127' from Oak Street
20' deep to main
Gas 3' off of pavement
