Name **Harley Hansen**

Address **19 Middleby Road****19 Middleby Rd.**

TOWN OF LEXINGTON — BOARD OF PUBLIC WORKS
SEWER DIVISION

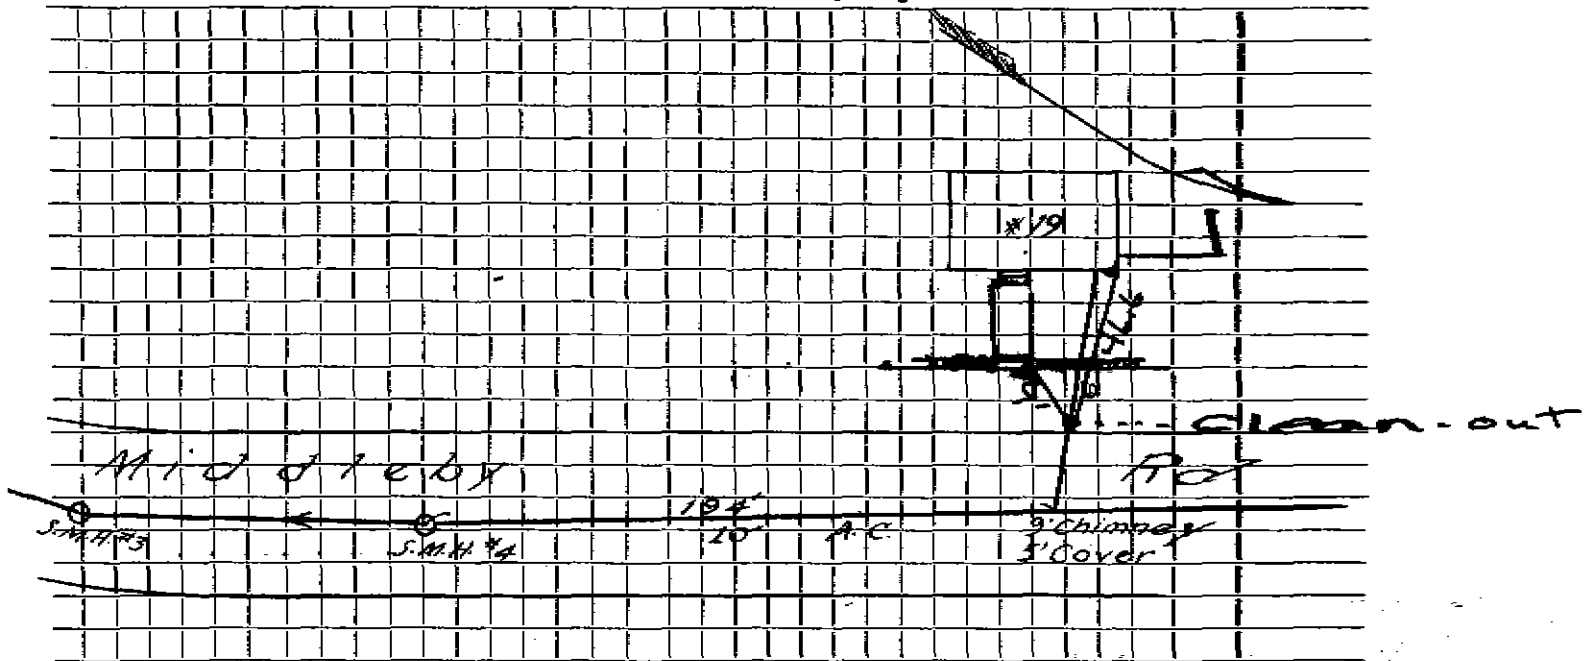
Sketch of Service Here

Connection made in Street. Work completed

Remarks: Clean out installed 11-14-95 Just below service marked with
and Curb Rods.....
