Address 28 Woodback Circle

SEWER DIVISION

TOWN OF LEXINGTON — BOARD OF PUBLIC WORKS

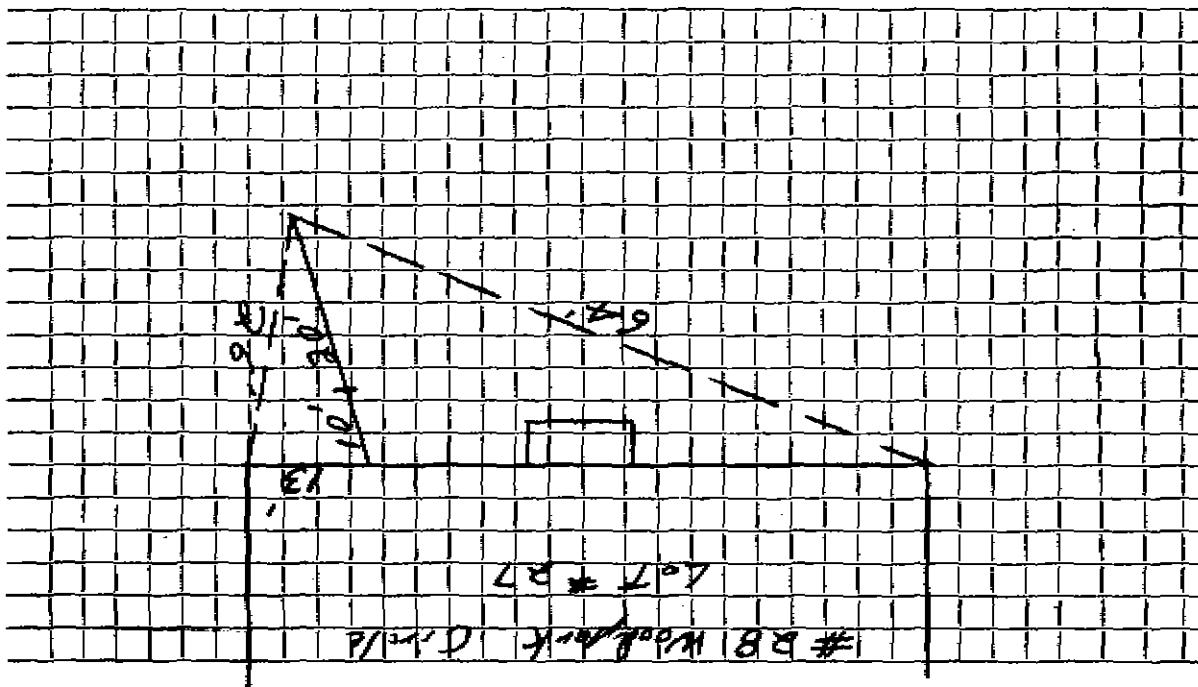
Sketch of Service Here

Connection made in wood perch larch steel. Work completed.
