WATER SERVICE RECORD

Address 42 BAKER AVE

TOWN OF LEXINGTON — BOARD OF PUBLIC WORKS

WATER DIVISION

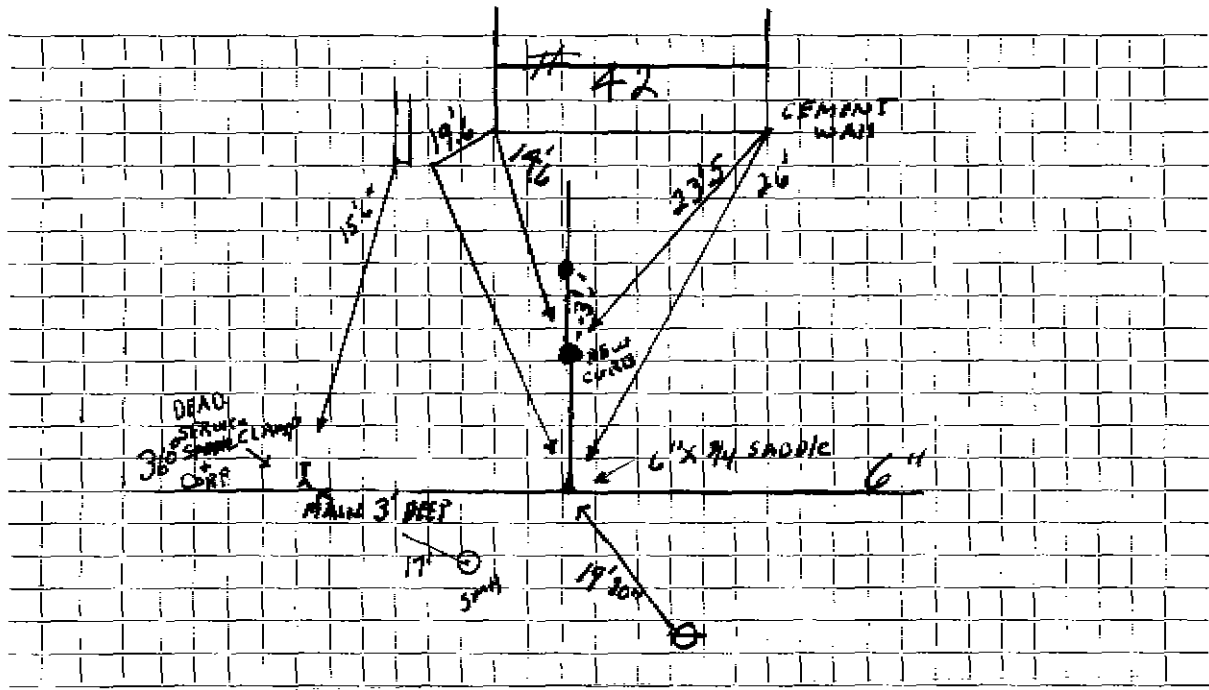
Sketch of Service Here

Remarks: GOOSE NECK OFF CURB, 2' 2" Deep INSULATION MAIN TO CURB  
7.2.96 INSIDE RENEWED TO NEW CURB - tie the same

Date	Material	Amount	Total	Date	MELANDESON.	Amount
8-24-90	6" x 3/4" SERVICE SADDLE			8-24-90	INSIDE-LEAD OFF CURB	
	3/4" COPR					
	3/4" CURB COMP.			7-2-90	INSIDE RENEWED	
	8' - 3/4" COPPER					
	BOX + ROD				20' COPPER 3/4"	
	INSULATION MAIN TO CURB
