**Ecological LAND MANAGEMENT AND DESIGN PLAN FOR**

# **Willard's Woods**

**LEXINGTON, MASSACHUSETTS**

*November 2021*

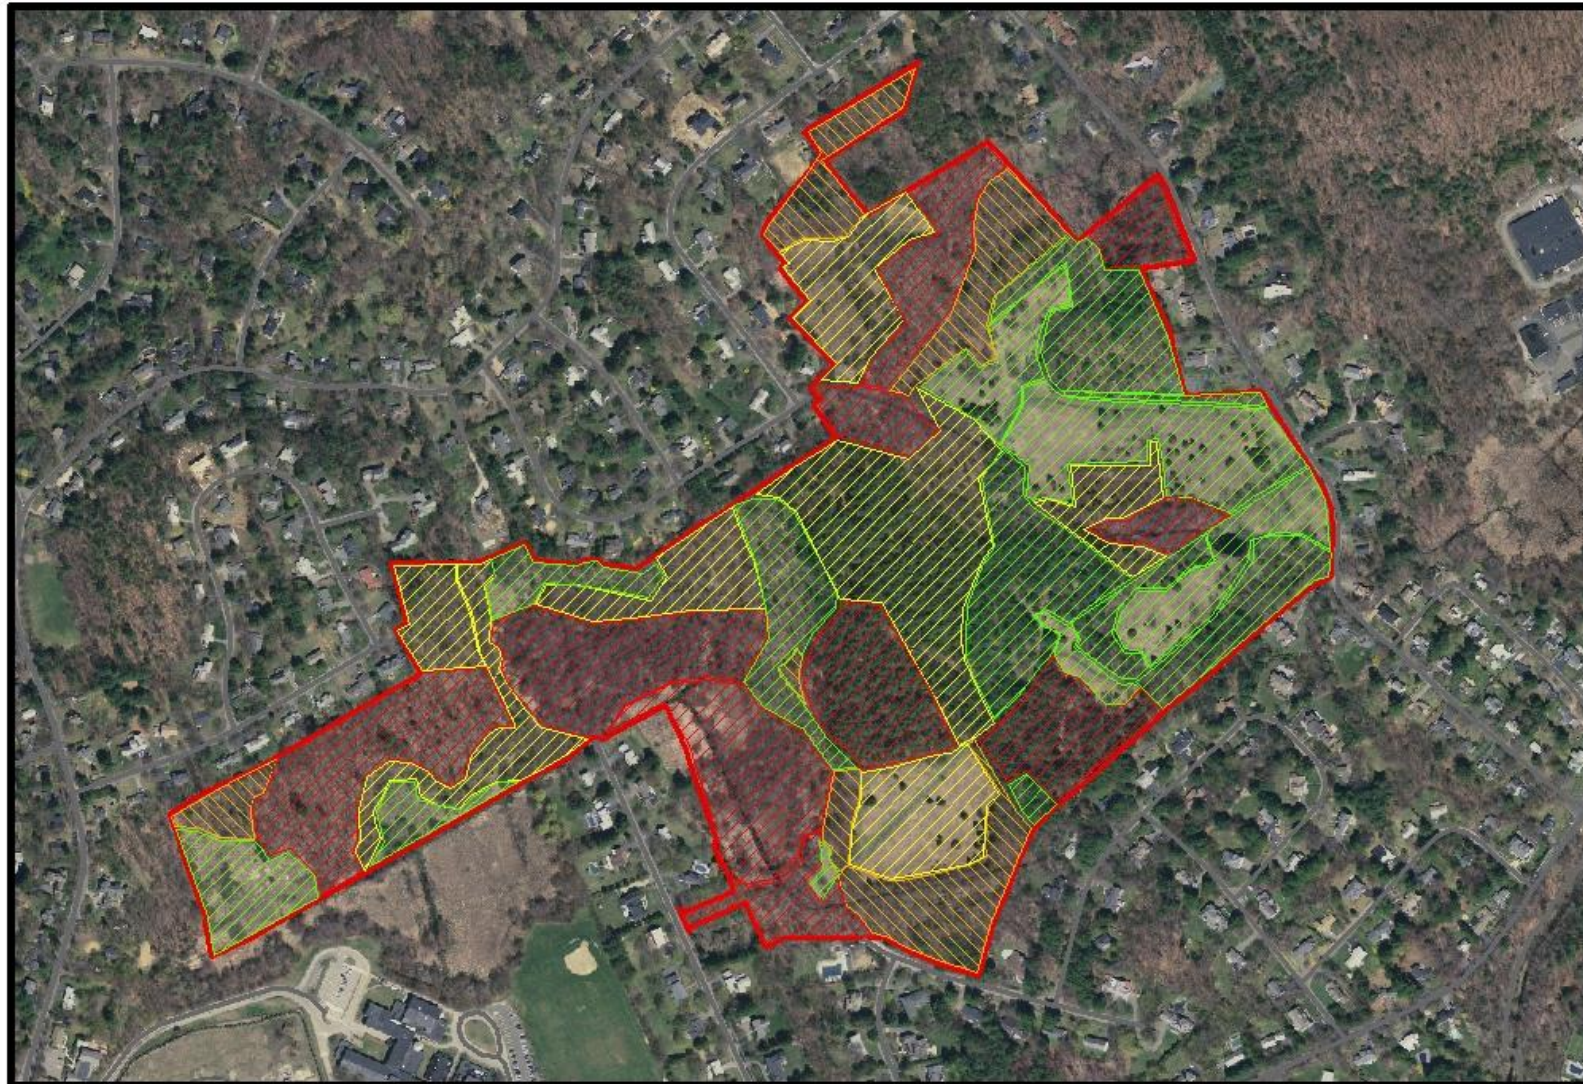
Figure 3. Map displaying glossy buckthorn (*Frangula alnus*) densities at Willard's Woods

invasive plant management at Willard's Woods. Purple loosestrife, though not listed as a high priority species, is known to take over fields very quickly. At the time of the visit, these plants looked healthy, with no evidence of damage from the *Galerucella* biocontrol beetles. It is currently at low enough densities to be considered an early detection species and managing it now would take only a minimal effort and would prevent it from establishing. Though not previously identified at Willard's Woods, it will be important to keep a look out for other priority early detection species such as Japanese stilt grass (*Microstegium vimineum*) and mile-a-minute (*Polygonum perfoliatum*) in the years to come. These species are prevalent in the eastern part of the state and early detection is key to their successful management. Further, black walnut (*Juglans nigra*) was identified on site, both mature well-established trees as well as saplings starting to establish themselves in the field. This species is not currently listed as an invasive in the state of Massachusetts, but it can also take over fields quickly, and should be monitored closely as well as treated alongside other invasive plants in any field management activities. See Table 2 below for the full list of invasive plants identified at Willard's Woods during our 2019-2020 assessment. Invasive plant population maps are provided for reference below (Figures 3-6).

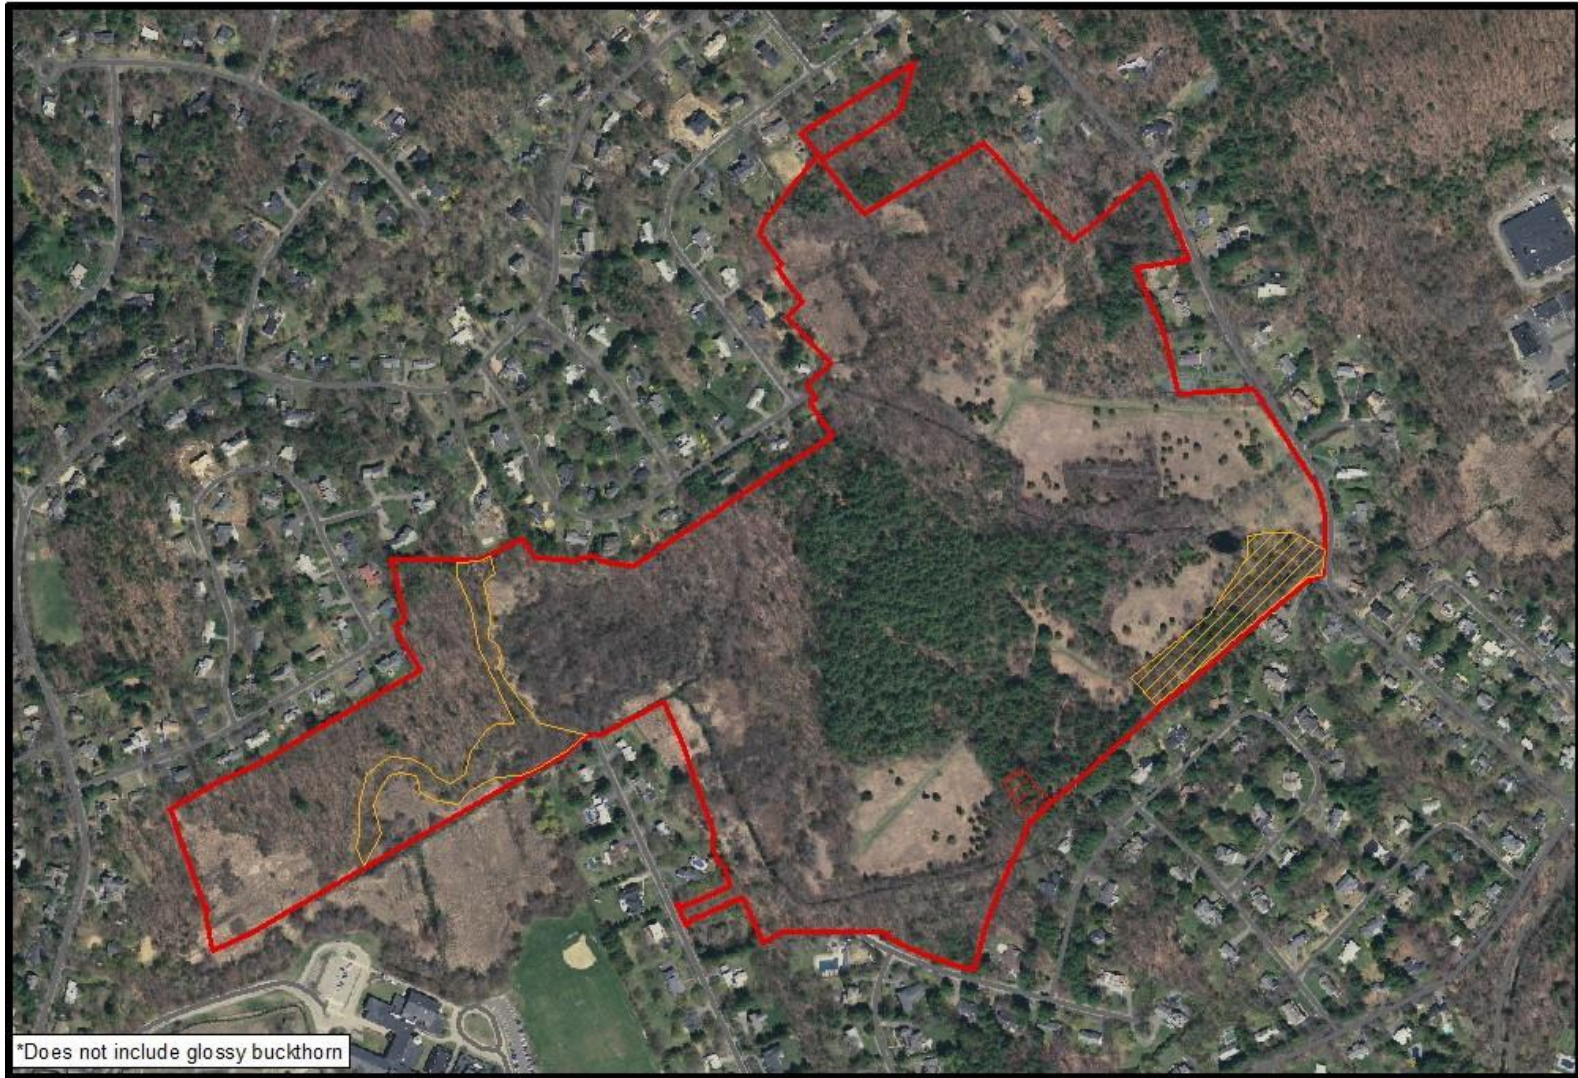
Figure 4. Map displaying high density invasive areas at Willard's Woods

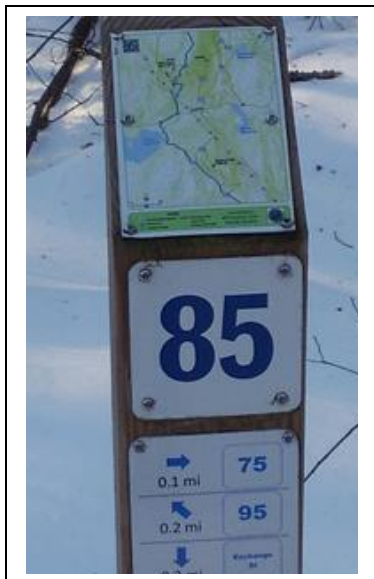
**Trail Signage:** CW recommends greater use of the metal trail signs shown in the photo to the left. They should be installed on posts at each trail intersection at a minimum.

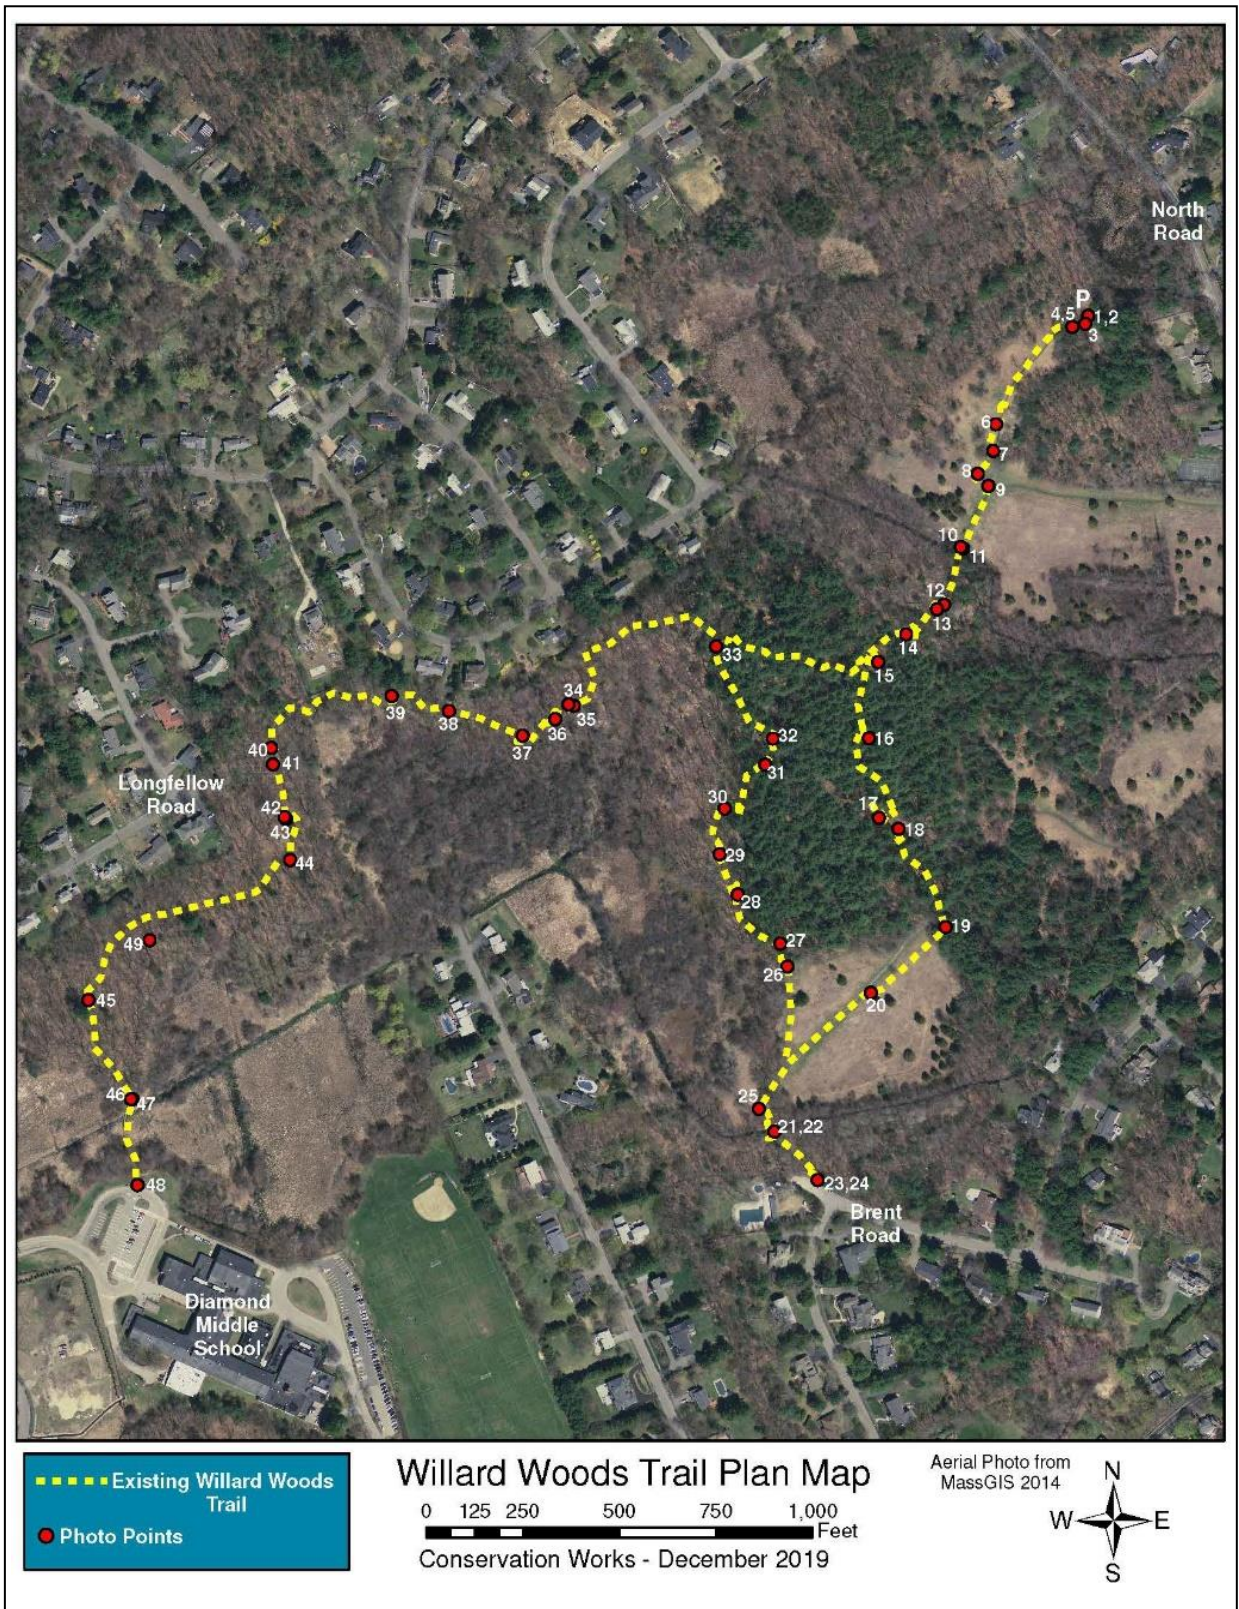
Figure 9. Willard's Woods Trail Plan Assessment Points

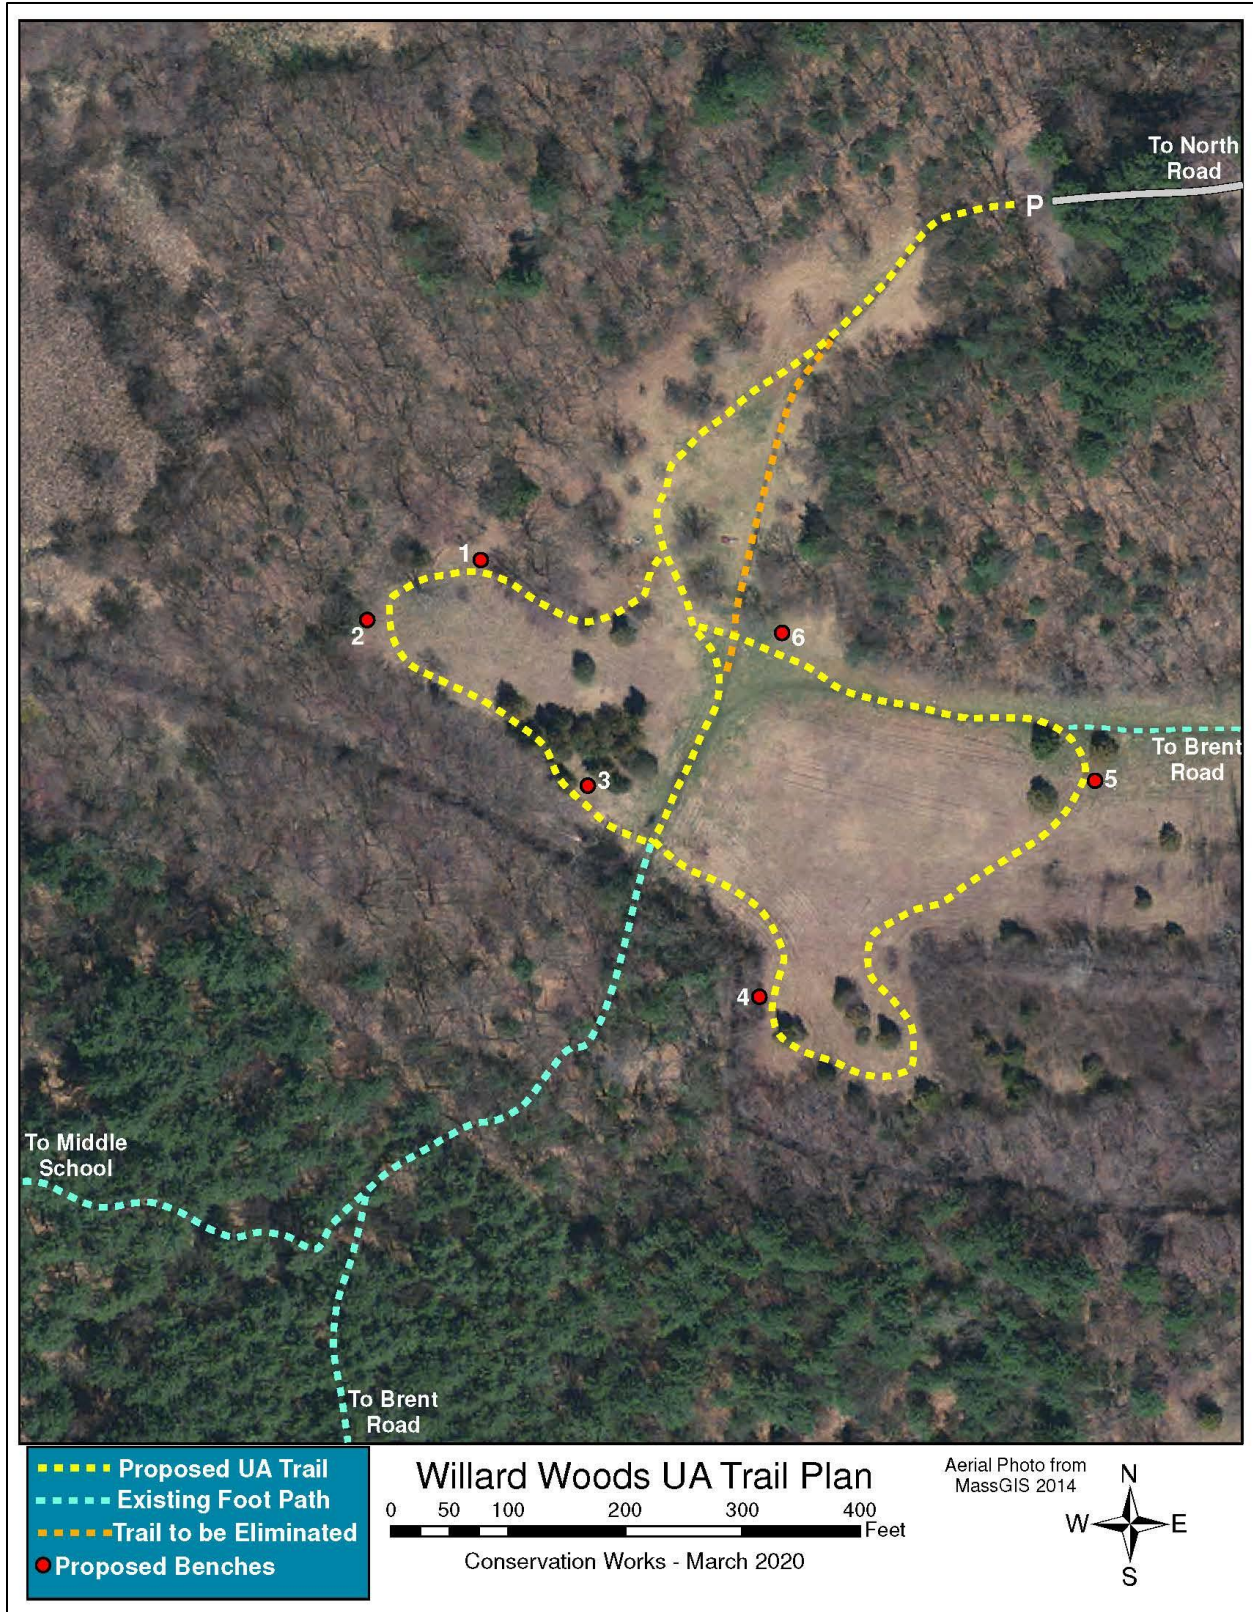
Figure 10. Willard's Woods UA Trail Plan Map
