WATER SERVICE RECORD

Address 12 Hancock street

TOWN OF LEXINGTON — BOARD OF PUBLIC WORKS

WATER DIVISION

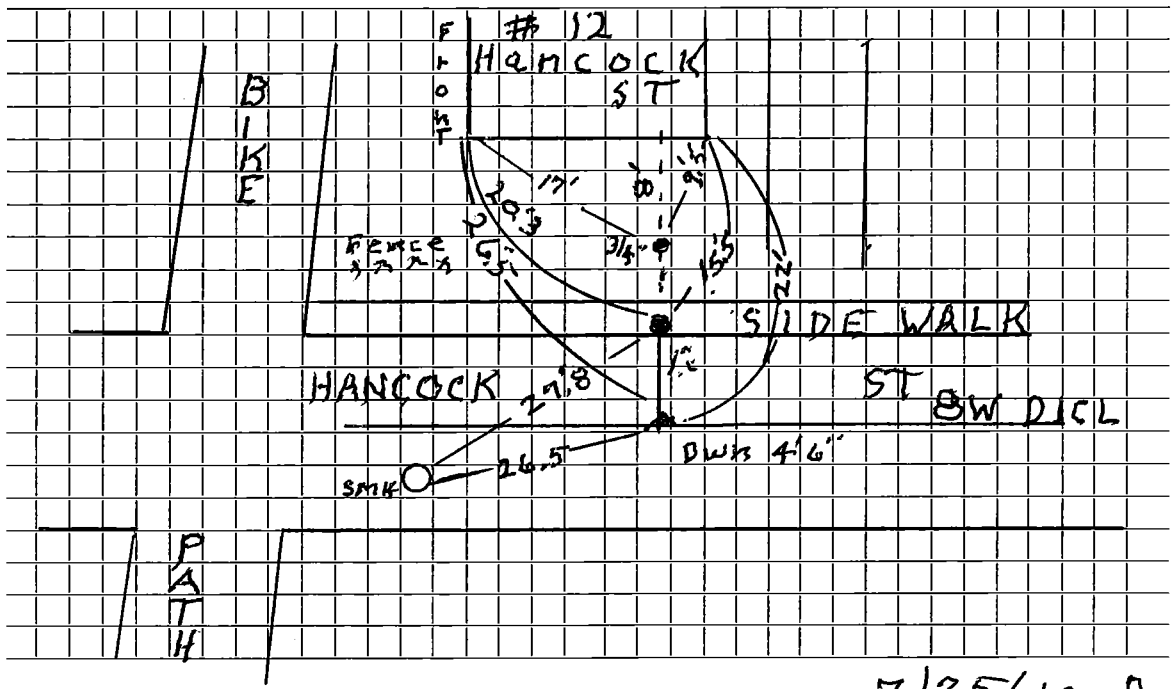
Sketch of Service Here

Remarks: 3/4 Curb Left IN Place behind fence

Repair—Renewal—New Service Main to curbstop. 7/25/12 Grange Defelice

Date		Material	Amount	Total	Date		Amount
7-25-12	2'+10'	12'- 1" Copper					
		1"- Corp.					
		1" Curb STop					
		1"x 3/4" Union					
		buffalo box					
1968 Exist	11'	3/4 copper To house					
		3/4 Curb-left IN place behind fence- ON
