WATER SERVICE RECORD

TOWN OF LEXINGTON — BOARD OF PUBLIC WORKS

Location HSR & MINUTE MAN LANE Date 10 NOV 11

1" Copper water service

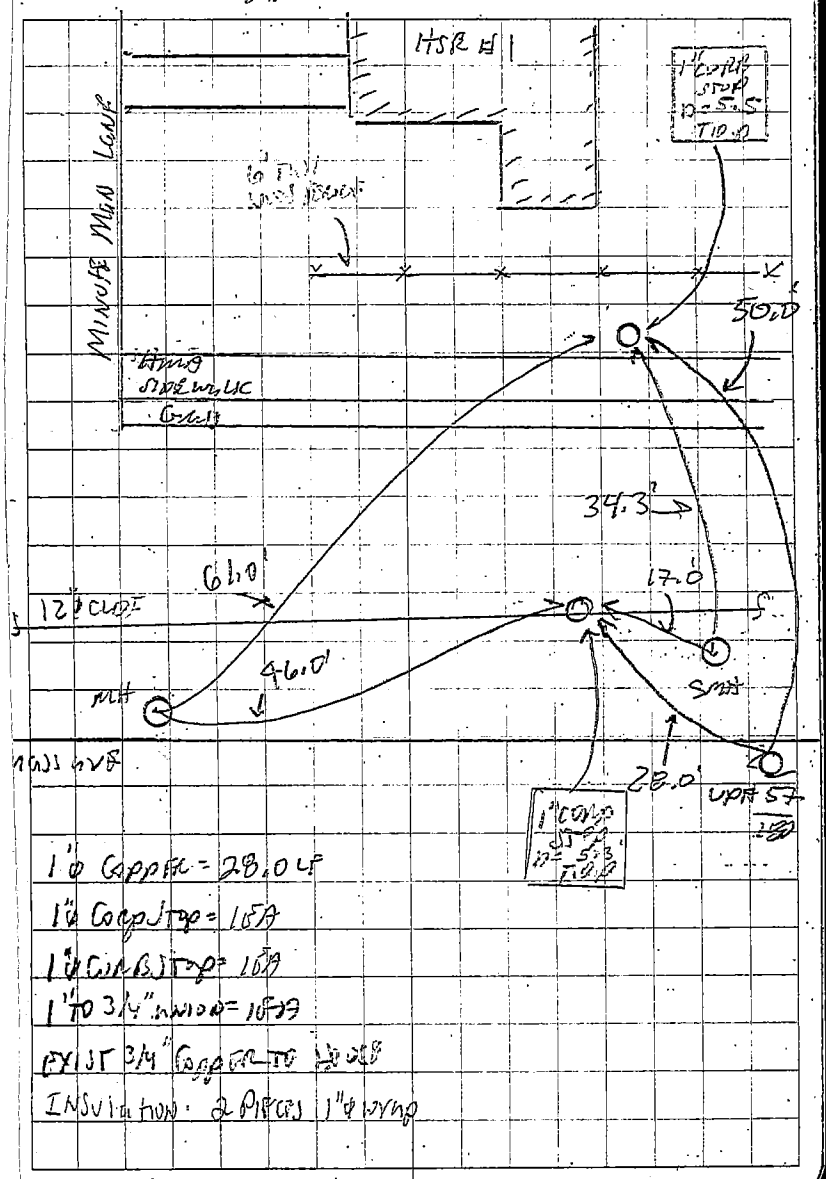
1" ø Copper = 28.0 LF

1" ø Copper = 1EA

1" ø Curb Stop = 1EA

1" to 3/4" Union = 1EA

EXIST 3/4" Copper to be reused

Installation: 2 pieces 1" ø Copper
