Vine Brook and Willard's Brook Stream Shoreline Surveys

May 9, 2009
Lexington, Massachusetts

Conducted by the Watershed Stewardship Program,
a joint program of Lexington's Conservation Division,
Engineering Division, and citizen volunteers

Compiled by Emily Schadler and Tom Whelan
December 8, 2009

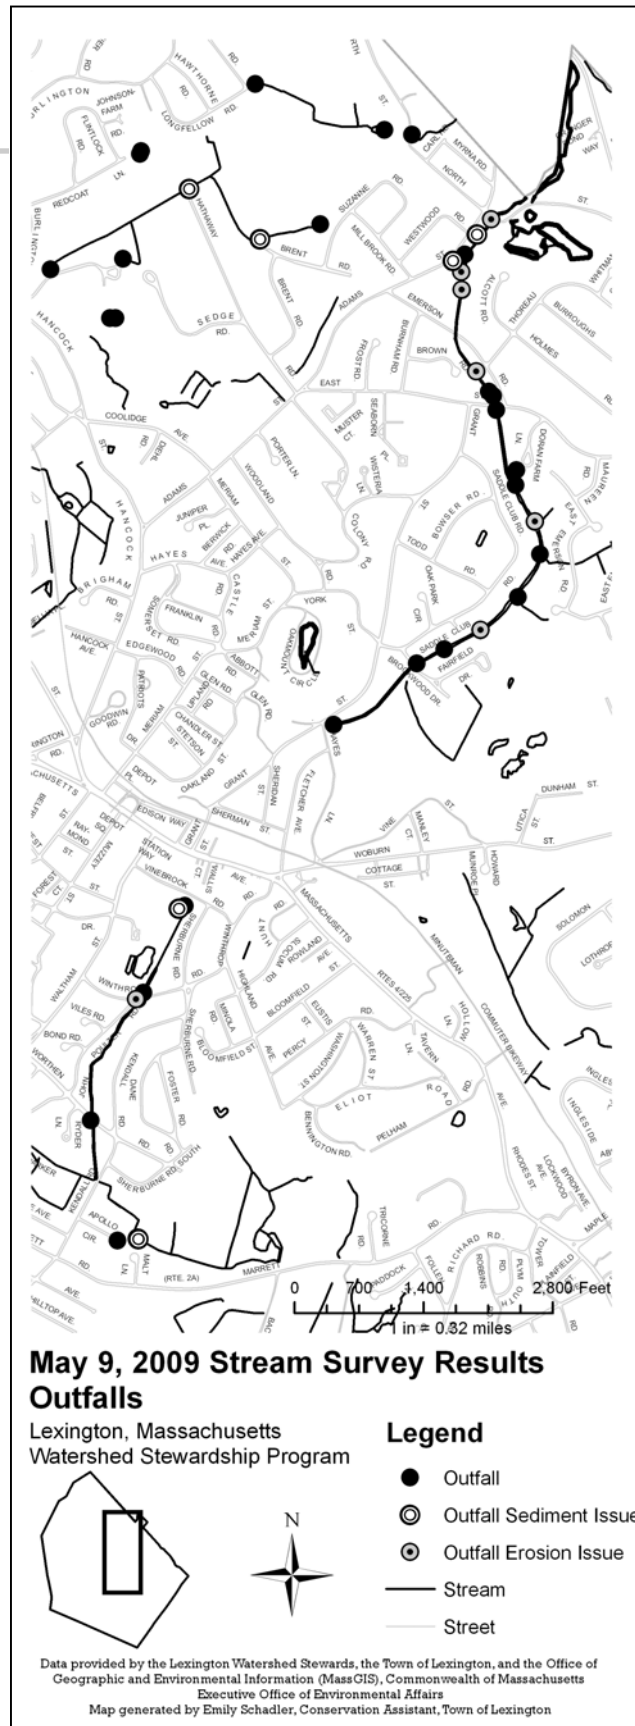
The **Outfalls map** to the right shows the locations of all outfalls identified in the survey. Volunteers were instructed to collect data on all pipes draining into the stream, so the map does not distinguish illicit connections. Outfalls with nearby excess sediment deposits and erosion issues are noted separately.

Outfall located on Vine Brook at Worthen Road.

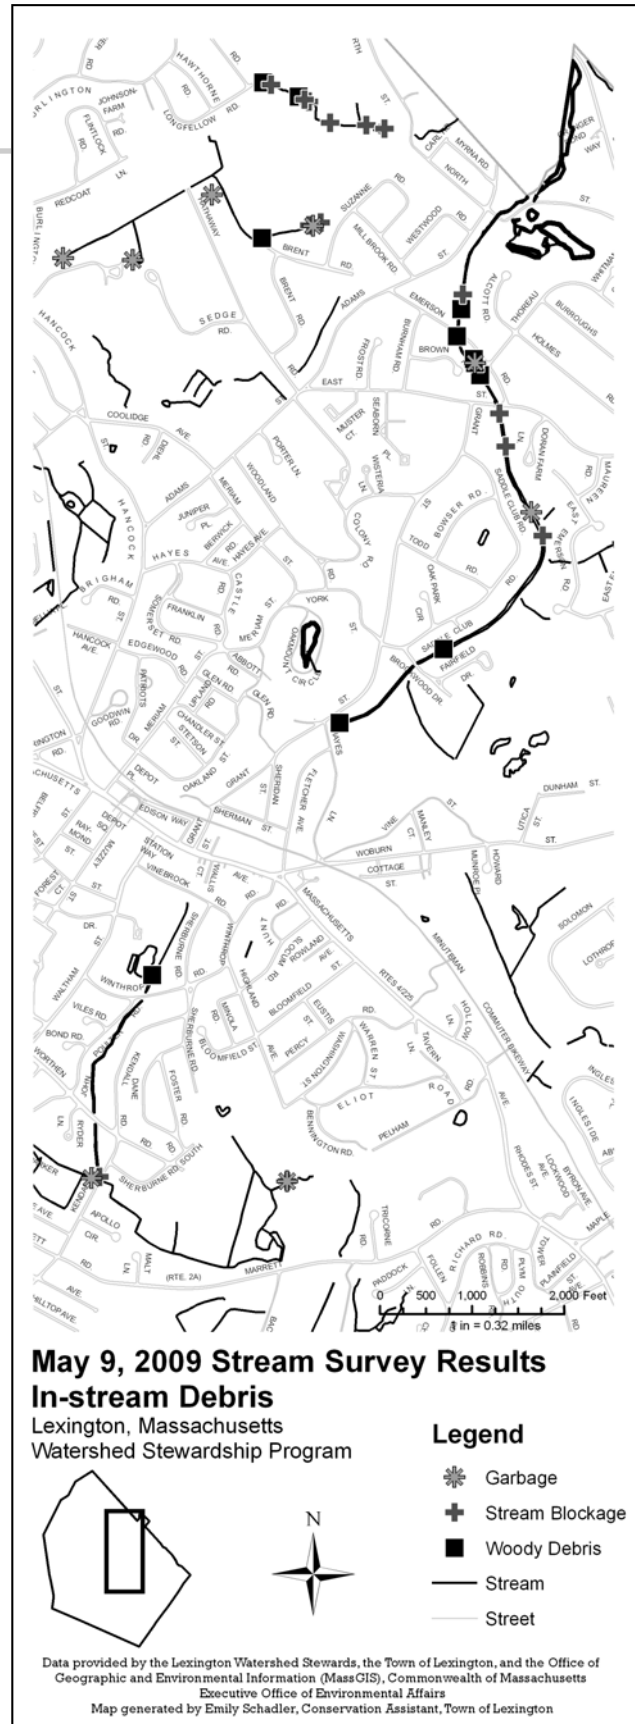
The **In-stream Debris** map to the right shows the location of 3 types of debris:

Woody debris and other organic matter spanning a stream bed.

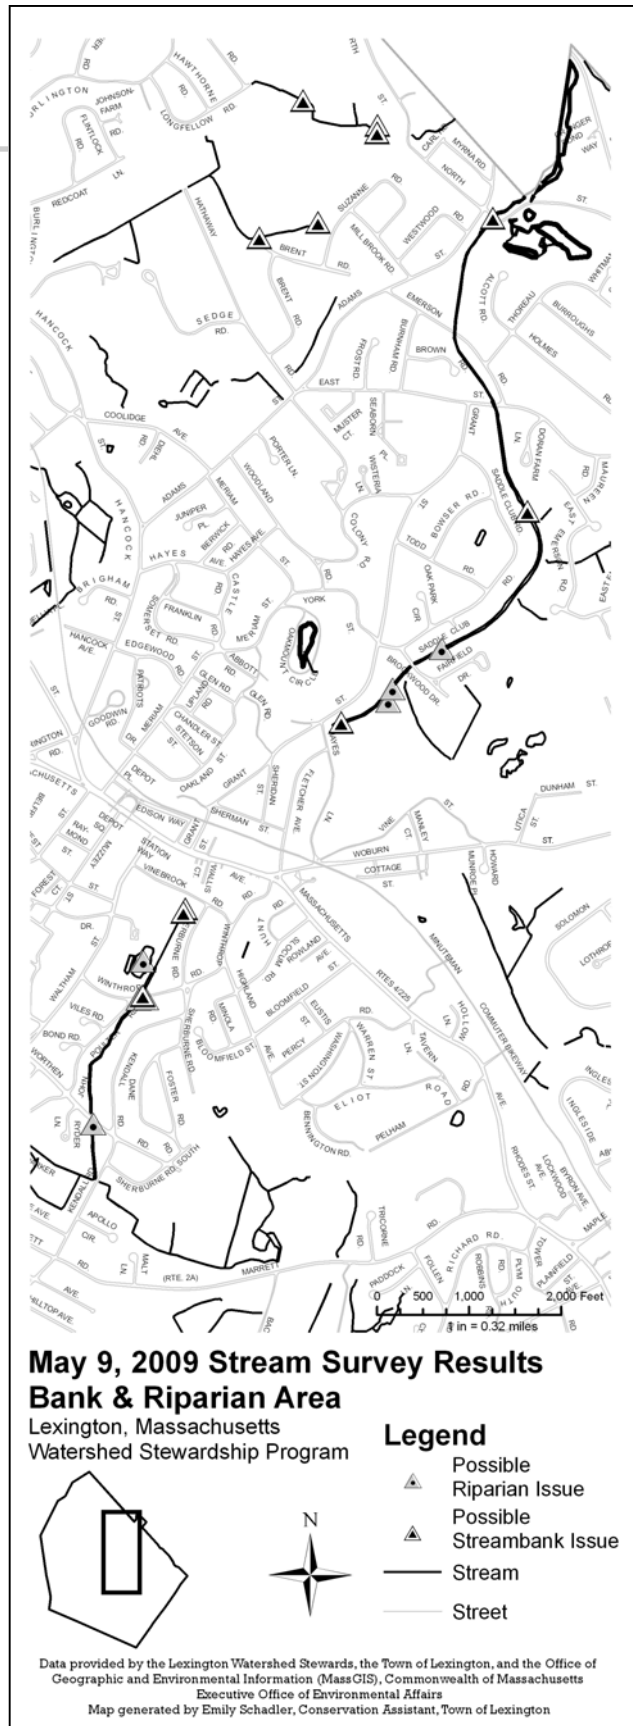
The **Bank and Riparian Areas** map to the right shows the location of possible stream bank issues, including severe or moderate erosion, riprap, exposed roots, grass, and landscaping debris located in the bank area, and possible riparian issue, including lawns, buildings, pavement, and invasive species in the riparian area.

Bank erosion on a stretch of Vine Brook.
