TOWN OF LEXINGTON — BOARD OF PUBLIC WORKS
SEWER DIVISION

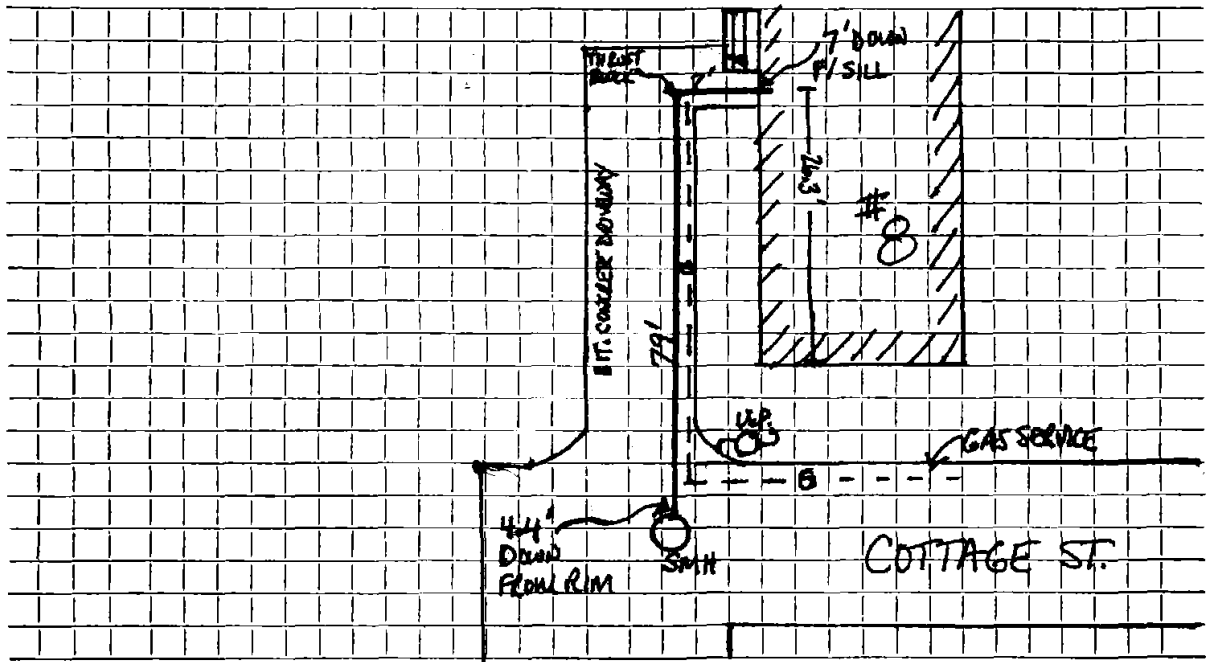
Sketch of Service Here

Connection made in Street. Work completed

Remarks: EXISTING GAS SERVICE IN SAME TRENCH/ BROKE/ REPAIRED BY BOSTON GAS

- 2" PVC INTO SEWER MANHOLE, 4-4" DOWN FROM RIM

- INVERT OUT OF HSE ~ 7' DOWN FROM SILL
