**Sewer Service Tie Card**  
**TOWN OF LEXINGTON**  
 MASSACHUSETTS

**5 Cutler Farm Road**

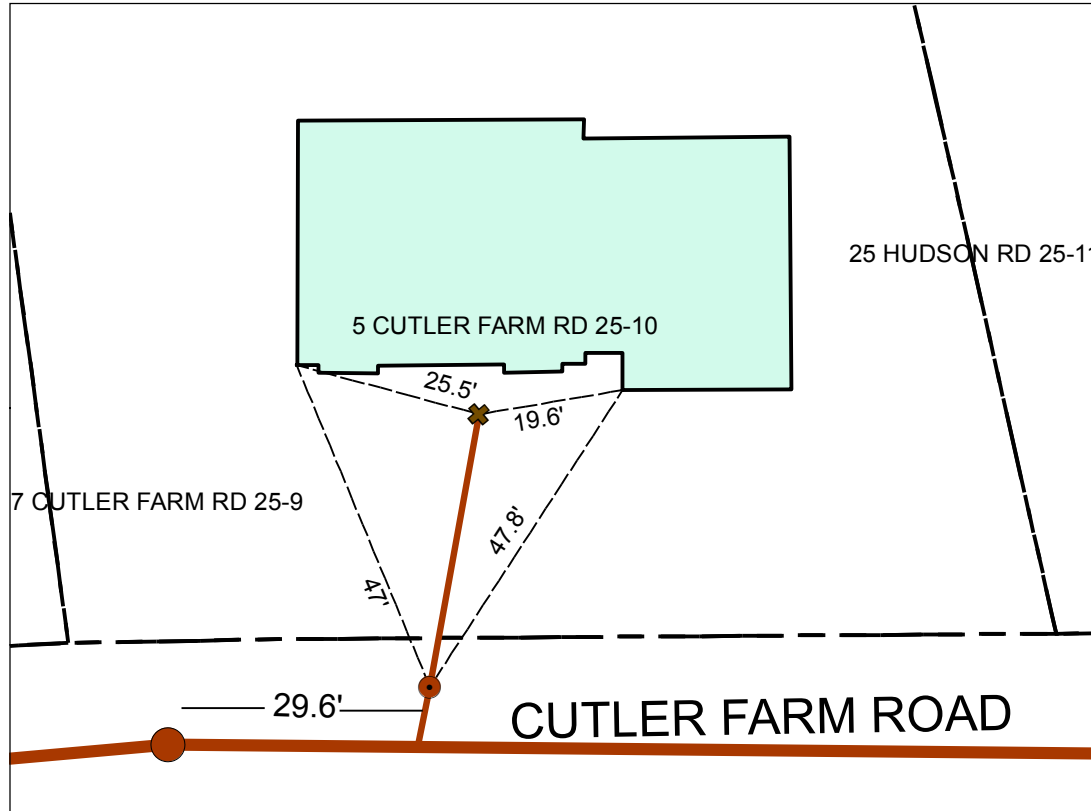
Date: 1/17/14	Material	Depth of Cover	Amount
	6x6 AC to PVC Fern Co	5.5 ft	Connect to existing stub
	6" PVC	7.5 ft	37.6 Feet to C.O.
	6"x4" Fern Co.	8 ft	Fern Co. at C.O.

**New 6" PVC sewer service installed from old sewer connection. New house built, old house removed.**
