**Sewer Service Tie Card**  
**TOWN OF LEXINGTON**  
 MASSACHUSETTS

**137 Grant Street**

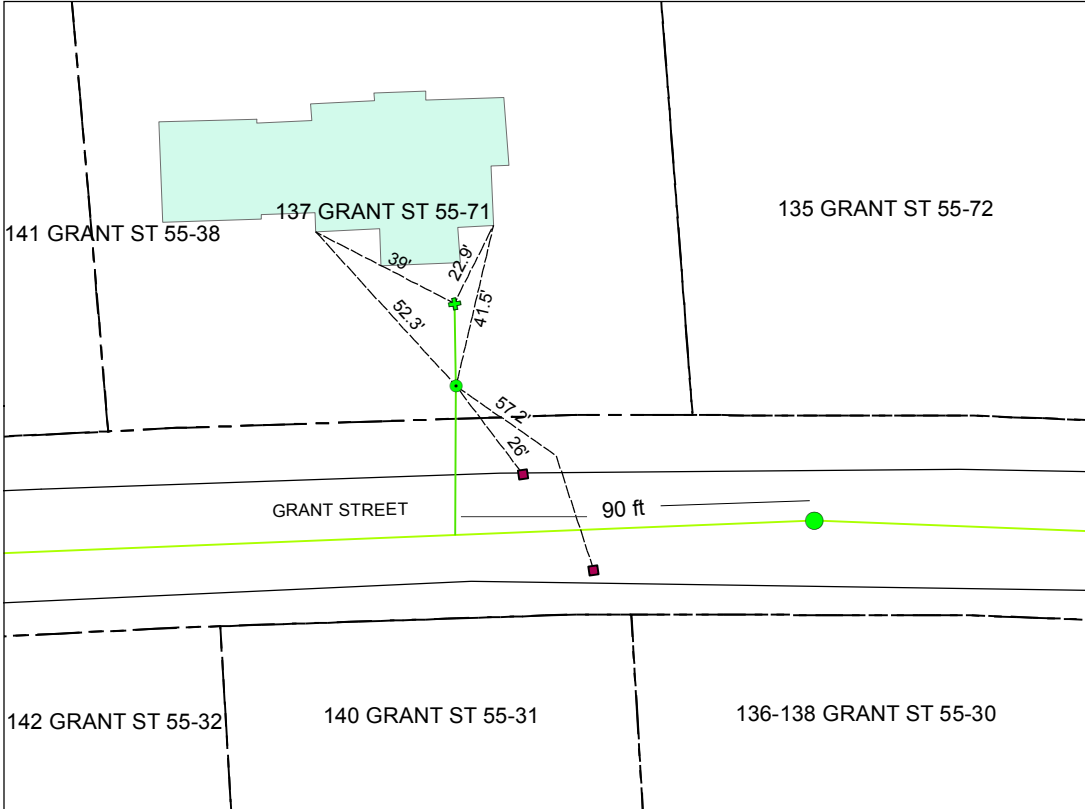
Date: 10/3/2013	Material	Depth of Cover	Amount
	6x6 AC to PVC Fern Co	6.5 ft	Connected to existing stub
	6" PVC	6.2 ft	20 Feet to C.O.
	6"x4" Fern Co.	6 ft	Fern Co. at Clean Out

**New 6" PVC sewer service installed from old sewer connection. New house built old house removed.**
