Address 68 Winters St

# TOWN OF LEXINGTON — BOARD OF PUBLIC WORKS

## SEWER DIVISION

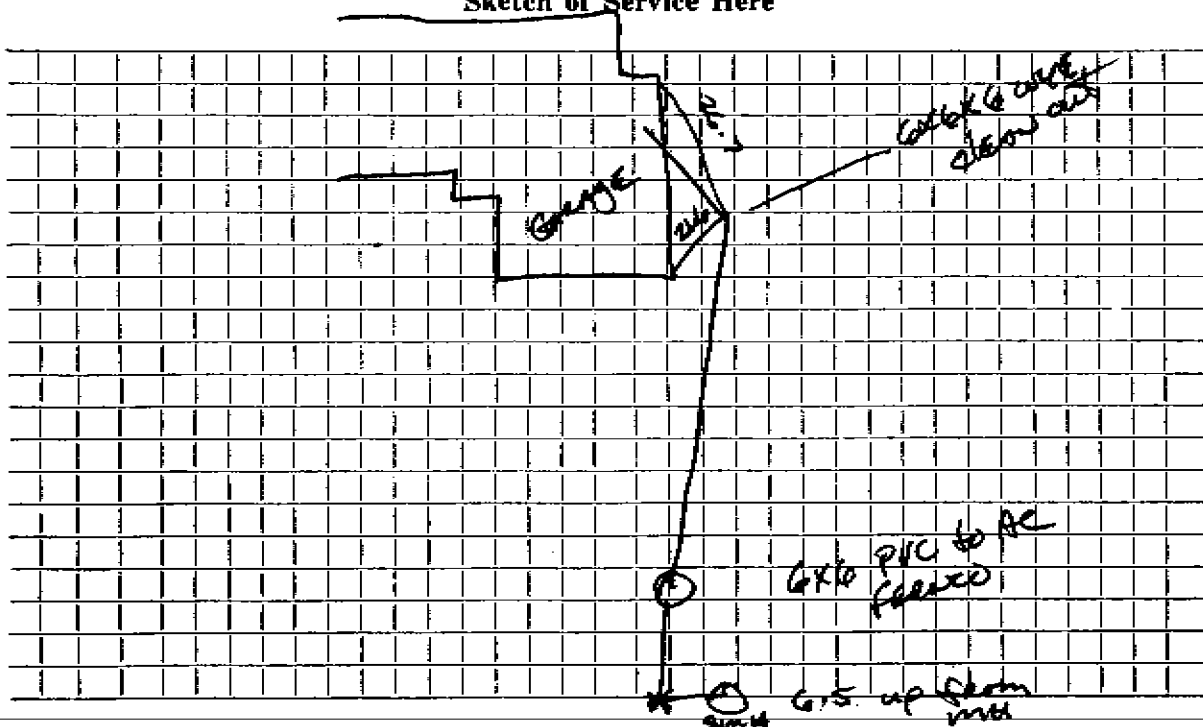
Sketch of Service Here

Service excavated inside

78' - 6" PVC

23 - 6" transit outside

10' - 4" PVC

6x4 - Franco

6x6x4 wye cleaned out

6x4 PVC to AC Franco
