WATER SERVICE RECORD

Location **413 BEDFORD ST**

TOWN OF LEXINGTON — BOARD OF PUBLIC WORKS

WATER DIVISION

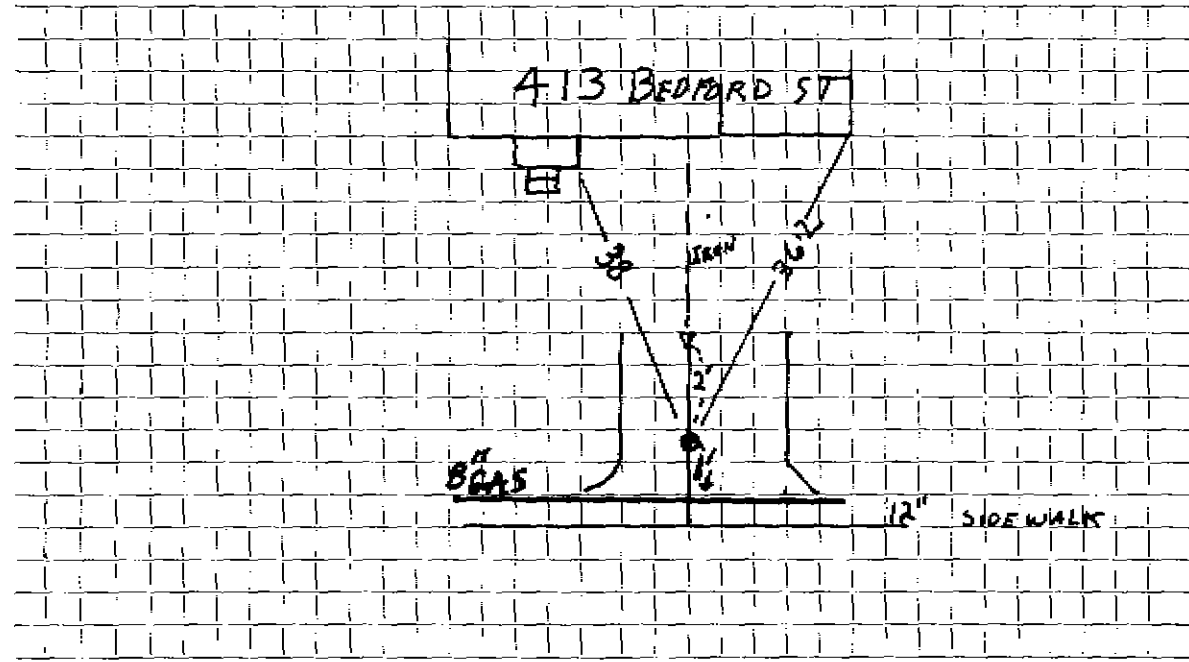
Sketch of Service Here

Connection made in 12" MAIN Street. Work completed

Remarks: BIG BOULDER HOUSE SIDE OF IRON CONNECTION (IT MOVED) COPPER IS 2' BELOW BOTTOM OF BOULDER

Date	Material	Amount	Total	Date	OUTSIDE	Amount
7/31/28	39' 3/4" CL PIPE			?	3/4" COPPER	
					3/4" COP	
					3/4" CURB	
				10/2/76	Buffalo Box	
					2' 3/4" COPPER	
					1" Iron x 3/4" COPPER	
					1" FX 3/4" C
