WATER SERVICE RECORD

Address 7 Bird Hill RD

TOWN OF LEXINGTON — BOARD OF PUBLIC WORKS

WATER DIVISION

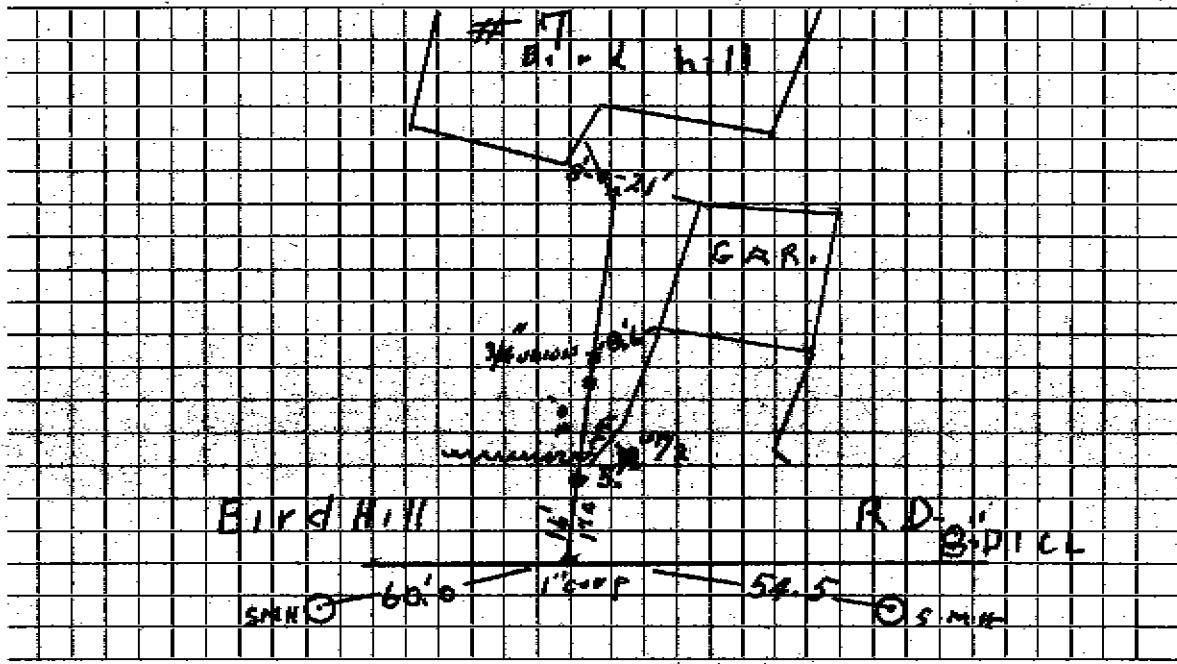
Sketch of Service Here

Remarks: Corp. DWN 4' 3" / Corp. DWN 4' 5" - 2009

Service broken 2 times by cont. 12-1-1988 - (Union's by Garage 2' deep. Owner told to lower.)  
Water Service, chose NOT to do it.

Date		Material	Amount		Total		Date	P.A.O	Amount	
12/1/88	Repair	3/4 Copper					7/27/09	16'	1" Copper	
		3/4 Comp. Unions							1" Comp	
		3/4 1/2 S.W.							1" curb box	
									1 1/2 Red	
									bufflo box

Connection made in ..... Street. Work completed 7/27/09 P.A.O. Corp.....
